# Manhole Inspection Summary

Manhole # S25OO1012MH

**Location** Address: **4607 ROLAND AVE**

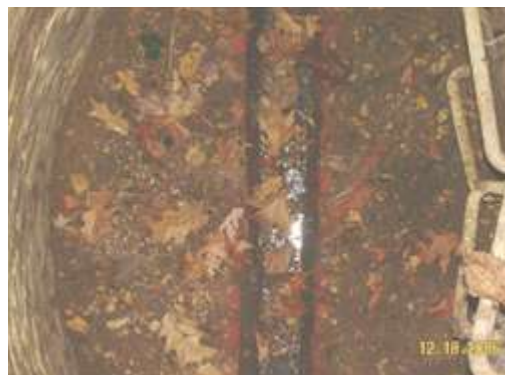
Top View

**Bench** ☒ Exists Material: **Brick** ☐ Parged ☒ **Debris** (not Condition related)

Bench debris.

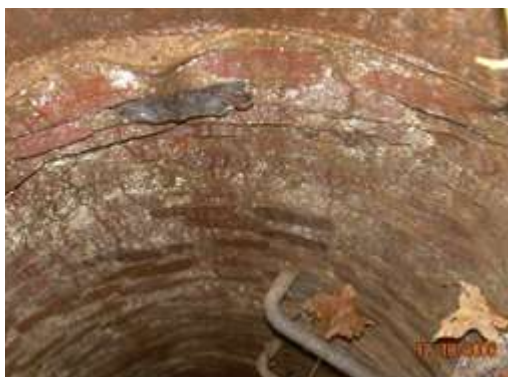
Defect

**Frame** Offset: **1** (in.) Condition: ☐ Sound ☐ Cracked ☒ **Leaks**

Infiltration: ☐ None ☒ **Joint** ☐ Cracks ☐ Mortar ☐ Roots ☐ Wall

Frame leaks. Adjustment infiltration.

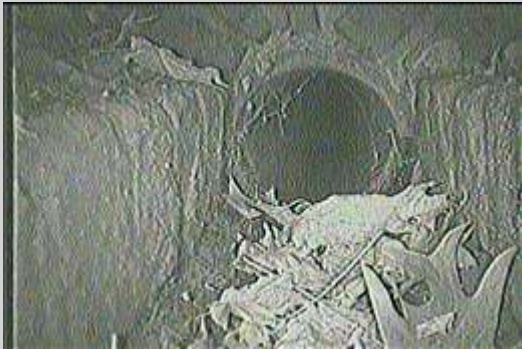
Pipe Out @ 12 O'Clock

Pipe Material: **Clay** ☐ Pipe Lined

Invert Depth: **10.89** (ft.) Flow Characteristics: **Slow**

Deposits: ☒ None ☐ Mud ☐ Sludge ☐ Debris ☐ Grease

Infiltration: **None** Pipe Seal Cond: **Unknown**

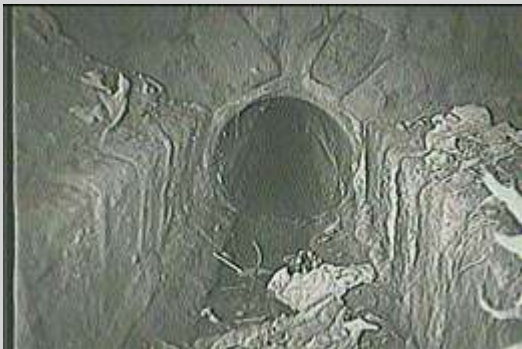
Pipe In @ 6 O'Clock

Pipe Material: **Clay** ☐ Pipe Lined

Invert Depth: **10.78** (ft.) Flow Characteristics: **Slow**

Deposits: ☒ None ☐ Mud ☐ Sludge ☐ Debris ☐ Grease

Infiltration: **None** Pipe Seal Cond: **Unknown**
